Property Inspection Report

8 New Home Lane
All Towns, Vermont

Prepared for: Mr. and Mrs. Smart Buyer

Prepared by: Cramer Home Inspection Group, Inc.
7 Christmas Road
Montgomery Center, Vermont 05471

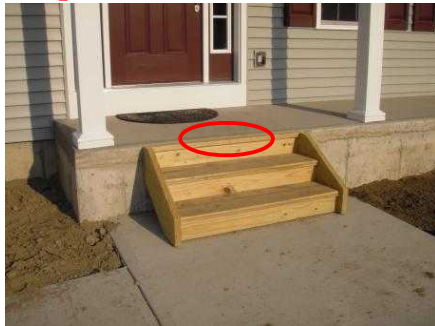
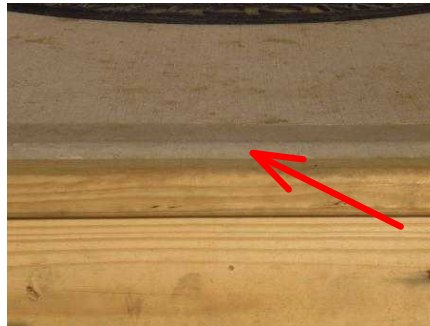
Steps/Stoops: Wood- Wood steps at front of home are not level with landing(photo #2) and may present a tripping hazard. Also steps are attached by steel nails. Over time these nails will deteriorate (rust and possibly fail)due to the chemicals in the treated wood as well as moisture that gets between steps and concrete. For improved safety its urged that you have qualified contractor install and secure proper steps.

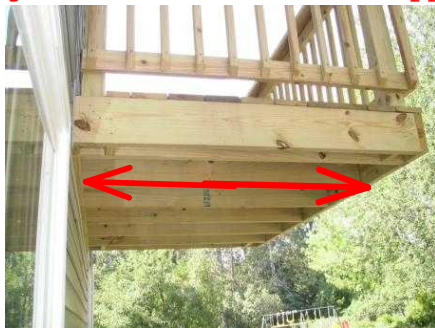
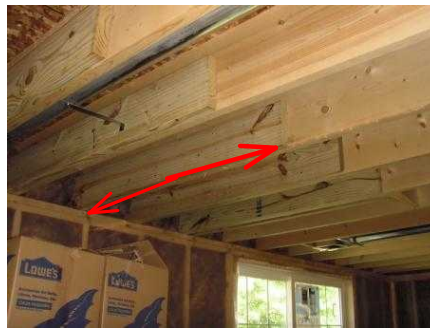
Balcony: Pressure treated wood, Wood railing- Balcony extends approx. five (5) feet from exterior of home (photo #1). Balcony framing extends approx. five (5) feet into the interior of home (photo #2). According to the International Building Code (IBC), "A cantilever back span must be 2:1" What this means is, if balcony framing extends 5 feet from home, twice that much framing (10 feet) must extend into home for proper support. At this point I would recommend that framing at the interior of home have thru-bolts installed in a staggered pattern at all balcony joists and for added support.

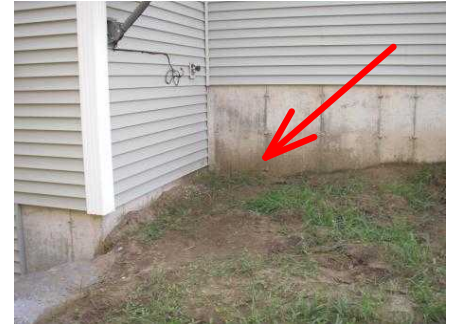
Grading: Moderate slope- **Improper soil slope towards foundation at various areas, recommend the addition of fill dirt to improve grade.**
NOTE: Grade should be evaluated after finish grade is complete.

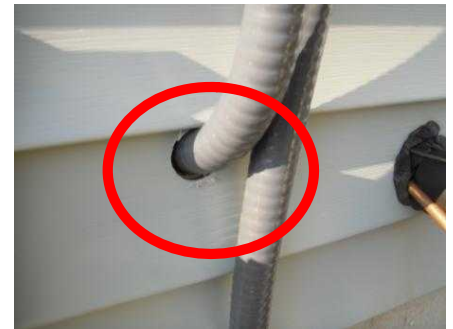
Type: vinyl siding- **Suggest caulking penetration where A/C electrical line enters home to prevent moisture/insect intrusion at wall area.**

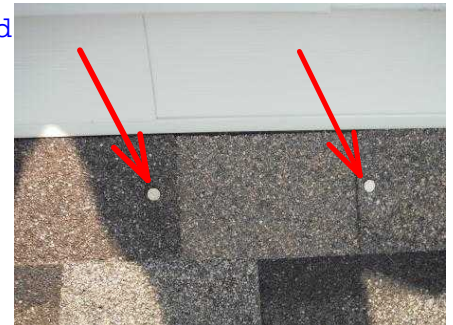
- Acceptable Material: Architectural shingles- **Caulk exposed nail heads at front porch.**

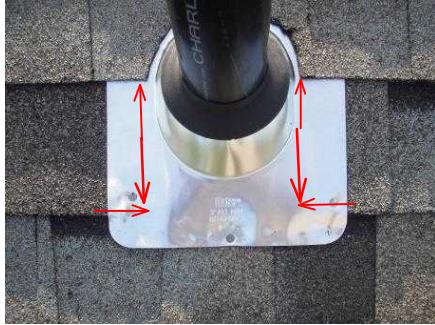
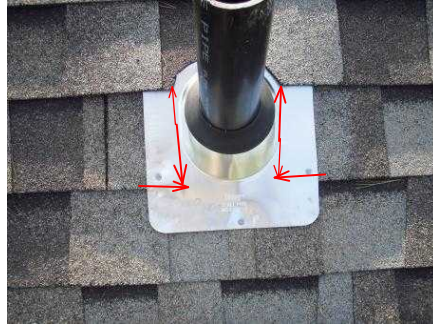
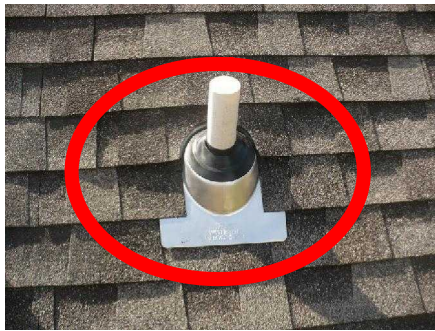
Flashing: (continued)

- Marginal Flashing: (2) Aluminum vent boot - **Vent boots have been incorrectly installed. Another course of shingles should have been extended over metal flashing (arrow). Photo #3(taken from another home) shows correct installation of vent boot flashing, Note no face nails. Recommend both vent boots be re-installed correctly to avoid moisture penetration.**

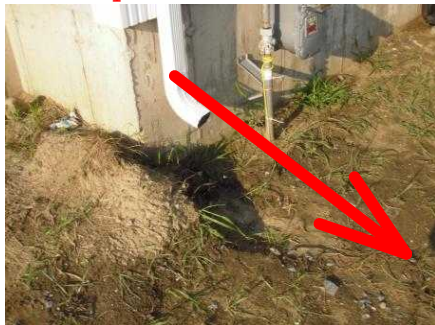
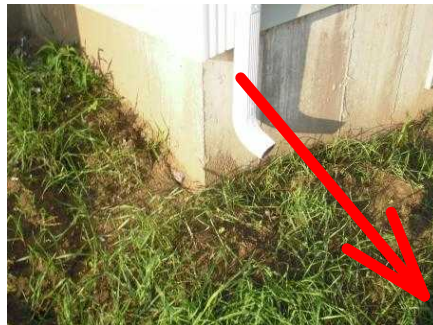
Leader/Extension: Missing- Recommend that leaders be installed as part of the gutter system and extend a minimum of 6' beyond foundation walls. This is an important measure in helping to maintain a dry basement. NOTE: Water that pools against foundation may eventually find its way in.

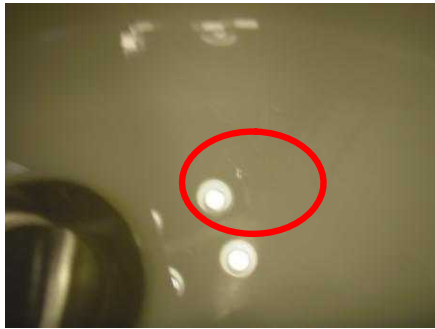
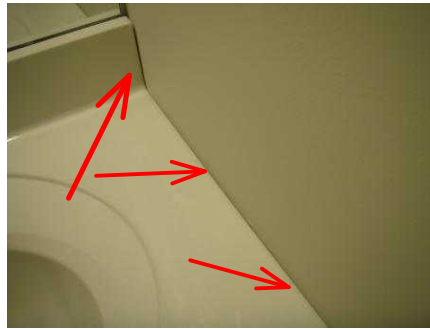
Acceptable Walls: Painted Drywall
Acceptable Floor: Vinyl floor covering
Acceptable Doors: Wood
Acceptable Electrical: Vent fan/ light/GFCI outlet
Acceptable Counter/Cabinet: Wood cabinet
Marginal Sink/Basin: One piece sink/counter top- Although difficult to see, 1st photo shows crack in sink. Over time this crack will expand and may leak eventually. Recommend sink/counter top be replaced. 2nd photo shows missing caulk at counter top and wall intersection. Recommend caulking be installed to prevent water from getting between vanity and wall.

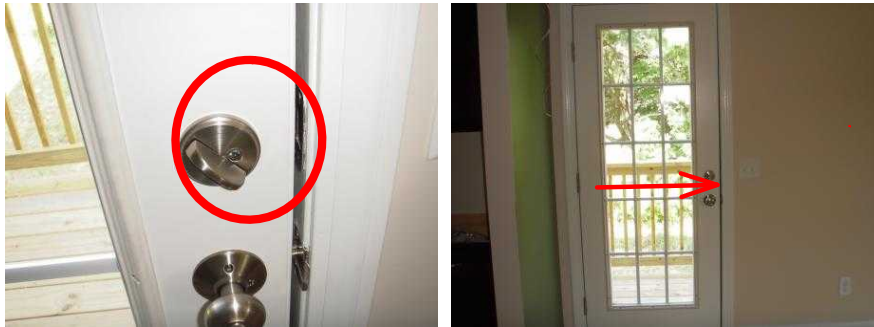
Acceptable Ceiling: Painted Drywall
Acceptable Walls: Painted Drywall
Acceptable Floor: Hardwood
Marginal Doors: Metal Entry Door- Dead bolt lock/strike plate (circled)needs adjustment for ease of operation. Also handle side of door jam is bowed away from door slab. This may compromise the weather striping and let cold air enter. Recommend door be re-shimmed for an air tight fit.

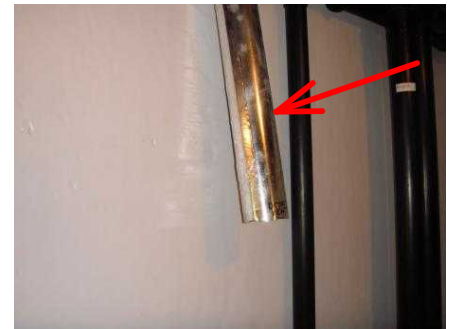
Marginal Dryer Vent: Rigid metal- Dryer vent pipe is not secured and can be moved freely. Recommend this be secured to wall.

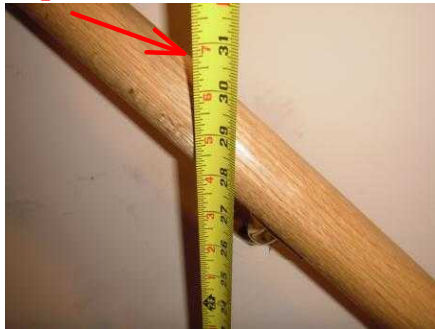
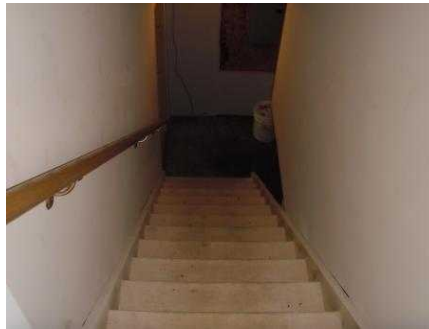
Acceptable	Electrical: Lights/ GFCI outlet (s)
Acceptable	Smoke Detector: Hard wired with battery back up and light
Acceptable	HVAC Source: Forced hot air
Acceptable	Insulation: Insulation panels, Fiberglass
Acceptable	Ventilation: windows
Not Present	Moisture Location: None noted at time of inspection
Marginal	Basement Stairs/Railings: Wood stairs with wood handrails- 1st photo shows railing height from tread nosing to be approx. 30 3/4 inches. International building code requires handrail height to be 34-38 inches above nosing. Recommend correction. Also according to IBC, "Where there are 6 or more risers at a stairway, a wall switch to control the lighting in the stairwell is required at each level". At time of inspection light in stairwell was missing. Recommend light be installed in stairwell as well as a 3 way switch that can control light from both the top and bottom of stairs be installed.

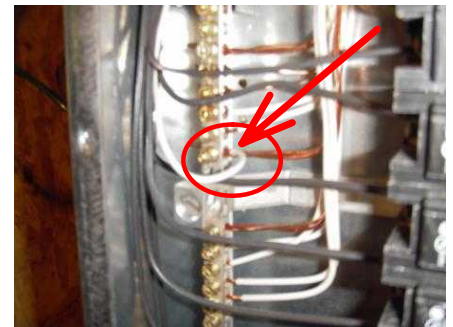
If the screw were loosened by an electrician or became loose, one would lose both the return path for current as well as the fault clearing ability should a hot contact a metallic surface. Recommend these be separated.

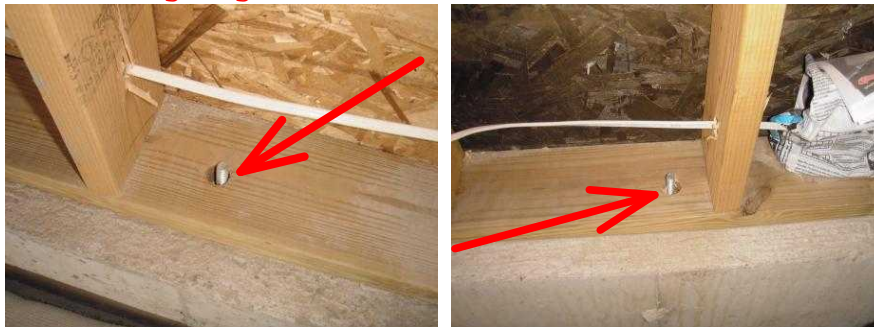
Acceptable Structure Type: Wood frame
Acceptable Foundation: Poured Concrete
Not Present Differential Movement: No movement or displacement noted
Acceptable Sills: 2x6 with sill seal
Marginal Anchor Bolts: All anchor bolts missins washers and nuts- **Anchor bolts must have washers and nuts installed according to IBC Code# R403.1.6. Recommend washers and nuts be installed at all anchor bolt locations at both the garage and home.**

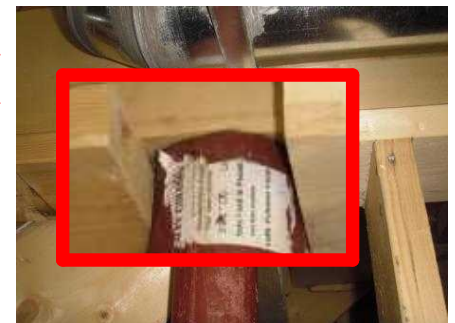
Acceptable Beams: Bonded wood
Acceptable Bearing Walls: Concrete foundation walls, Wood beams
Acceptable Joists/Trusses: 2x12
Marginal Piers/Posts: Steel posts- **Top plate missing at steel post. Weight has cause slight crushing of beam over post. Recommend that plate be install to properly support beam.**

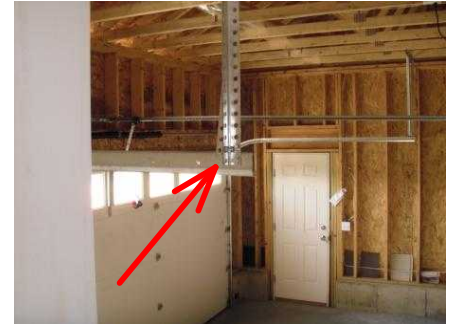
Garage Doors: Insulated aluminum- Aluminum door track presents a danger as it extends into garage stairway. Recommend door track be modified to prevent injury.

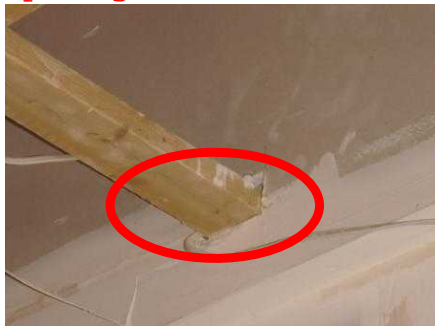
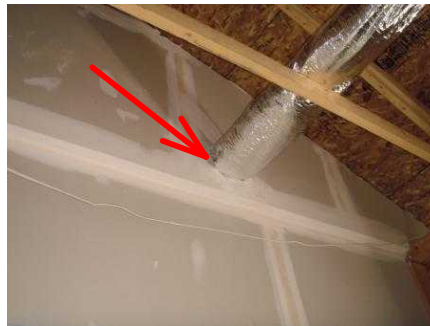
Door Operation: Mechanized
Door Opener: Overhead Door
Exterior Surface: Vinyl siding
Roof Structure: 2x4 Truss
Service Doors: Metal
Ceiling: Exposed framing
Walls: Painted Drywall, Exposed framing- There are openings in the firewall that have not been sealed. IBC requires any penetrations in firewall (wall between home and garage) to be sealed to prevent free passage of fire. Recommend fire caulking be installed to seal any openings in wall.

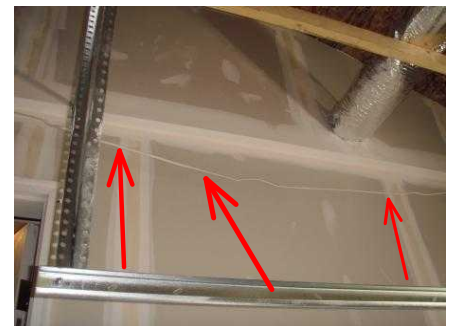
Floor/Foundation: Concrete
Electrical: Lights/ GFCI outlet (s)- Electrical wire is hanging unsupported. Recommend supporting wire a minimum of every 4 1/2 feet (IBC) to avoid physical damage to wire.

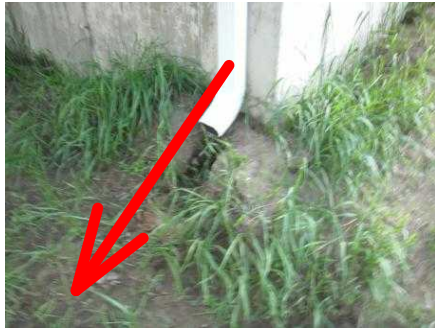
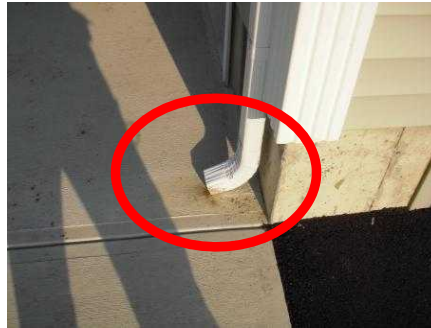
Leader/Extensions: Missing- Leader missing at back of garage (photo #1). Recommend that leaders be installed as part of the gutter system and extend a minimum of 6' beyond foundation walls. This is an important measure to assure water does not get under concrete slab and compromise its integrity. Water that gets under slab may heave concrete and cause damage during the freeze and thaw cycles. Use extreme caution when using garage service door in the colder months as water may freeze at sidewalk (photo #2).

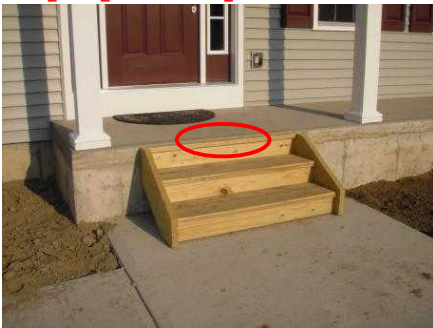
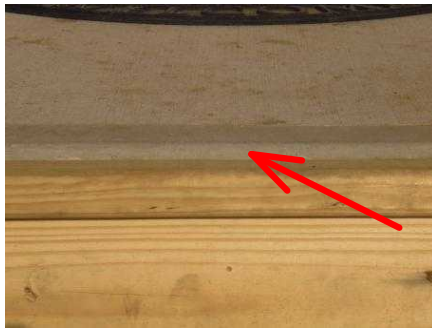
Steps/Stoops: Wood- Wood steps at front of home are not level with landing(photo #2) and may present a tripping hazard. Also steps are attached by steel nails. Over time these nails will deteriorate (rust and possibly fail) due to the chemicals in the treated wood as well as moisture that gets between steps and concrete. For improved safety its urged that you have qualified contractor install and secure proper steps.

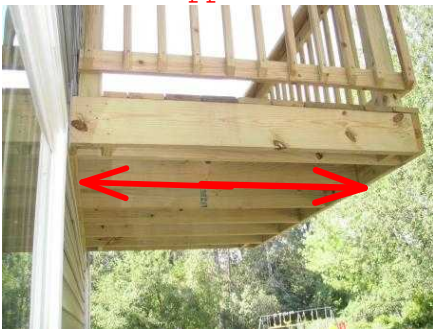
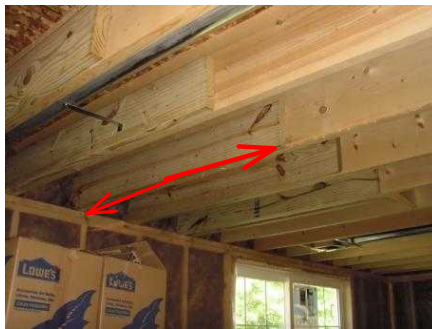
Balcony: Pressure treated wood, Wood railing- Balcony extends approx. five (5) feet from exterior of home (photo #1). Balcony framing extends approx. five (5) feet into the interior of home (photo #2). According to the International Building Code (IBC), "A cantilever back span must be 2:1" What this means is, if balcony framing extends 5 feet from home, twice that much framing (10 feet) must extend into home for proper support. At this point I would recommend that framing at the interior of home have thru-bolts installed in a staggered pattern at all balcony joists and for added support.

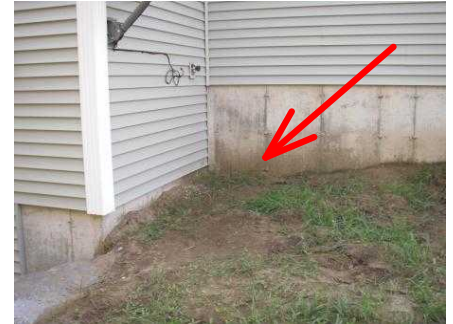
Grading: Moderate slope- Improper soil slope towards foundation at various areas, recommend the addition of fill dirt to improve grade. NOTE: Grade should be evaluated after finish grade is complete.

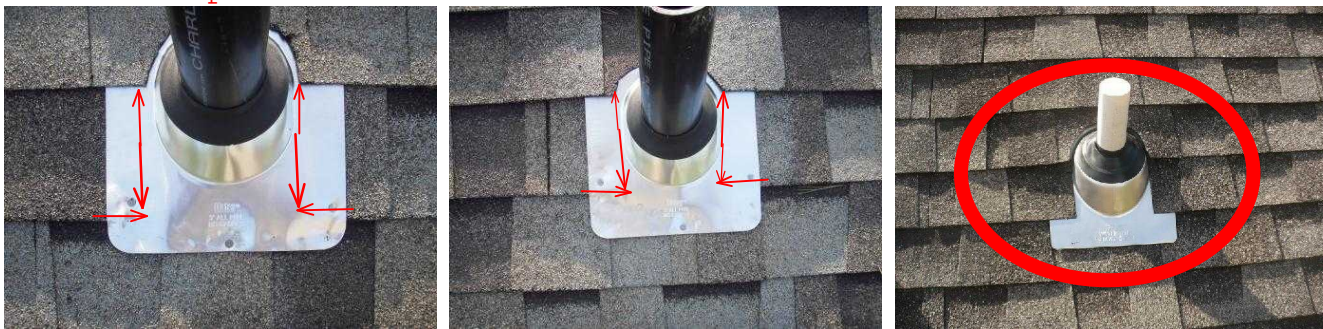
Flashing: (2) Aluminum vent boot - Vent boots have been incorrectly installed. Another course of shingles should have been extended over metal flashing (arrow). Photo #3(taken from another home) shows correct installation of vent boot flashing, Note no face nails. Recommend both vent boots be re-installed correctly to avoid moisture penetration.

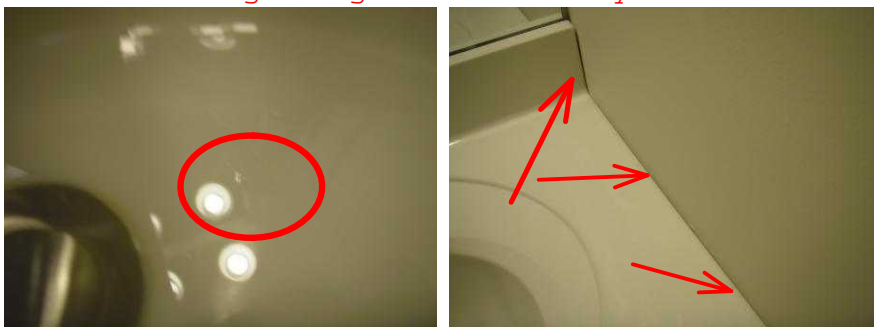
Half Bathroom Sink/Basin: One piece sink/counter top- Although difficult to see, 1st photo shows crack in sink. Over time this crack will expand and may leak eventually. Recommend sink/counter top be replaced. 2nd photo shows missing caulk at counter top and wall intersection. Recommend caulking be installed to prevent water from getting between vanity and wall.

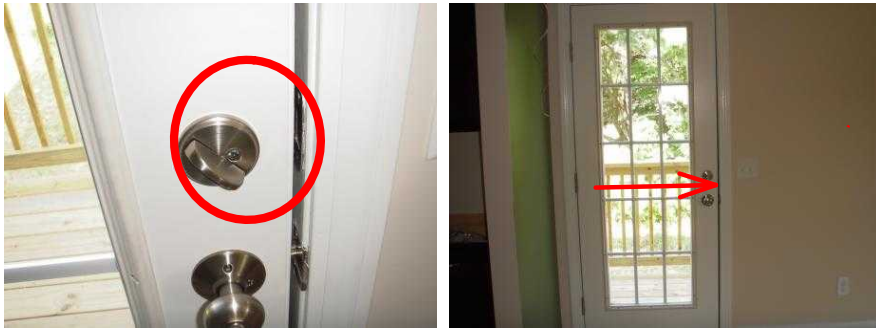
Living Room Living Space Doors: Metal Entry Door- Dead bolt lock/strike plate (circled) needs adjustment for ease of operation. Also handle side of door jam is bowed away from door slab. This may compromise the weather striping and let cold air enter. Recommend door be re-shimmed for an air tight fit.

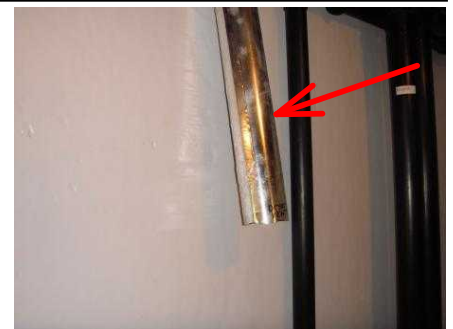
Basement Laundry Room/Area Dryer Vent: Rigid metal-vent pipe is not secured and can be moved freely. Recommend this be secured to wall.

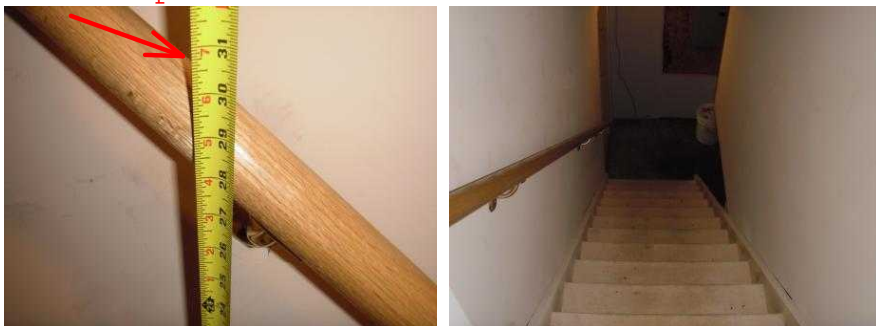
Basement Basement Stairs/Railings: wood stairs with wood handrails- 1st photo shows railing height from tread nosing to be approx. 30 3/4 inches. International building code requires handrail height to be 34-38 inches above nosing. Recommend correction. Also according to IBC, "Where there are 6 or more risers at a stairway, a wall switch to control the lighting in the stairwell is required at each level". At time of inspection light in stairwell was missing. Recommend light be installed in stairwell as well as a 3 way switch that can control light from both the top and bottom of stairs be installed.

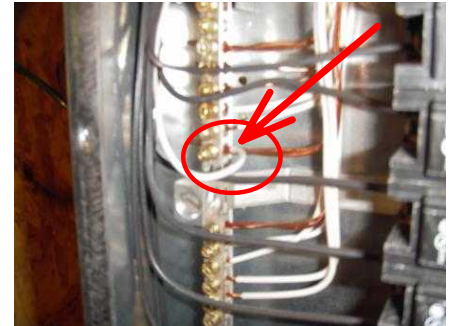
Basement Electric Panel Manufacturer: Cutler-Hammer- There is a shared neutral and ground under the same screw at bus bar in panel. The connection of a neutral and equipment-grounding conductor in the same termination creates an issue and is not an ideal configuration. If the screw were loosened by an electrician or became loose, one would lose both the return path for current as well as the fault clearing ability should a hot contact a metallic surface. Recommend these be separated.

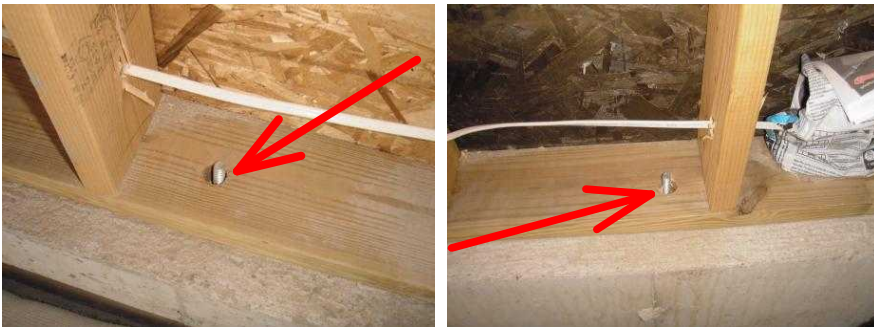
Anchor Bolts: All anchor bolts missins washers and nuts- Anchor bolts must have washers and nuts installed according to IBC Code# R403.1.6. Recommend washers and nuts be installed at all anchor bolt locations at both the garage and home.

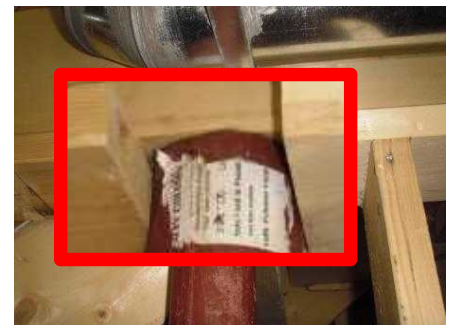
Piers/Posts: Steel posts- Top plate missing at steel post. Weight has cause slight crushing of beam over post. Recommend that plate be install to properly support beam.

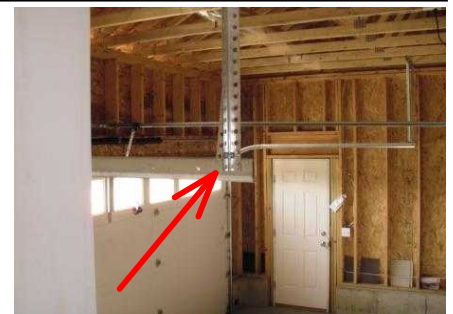
Garage Garage Doors: Insulated aluminum- Aluminum door track presents a danger as it extends into garage stairway. Recommend door track be modified to prevent injury.

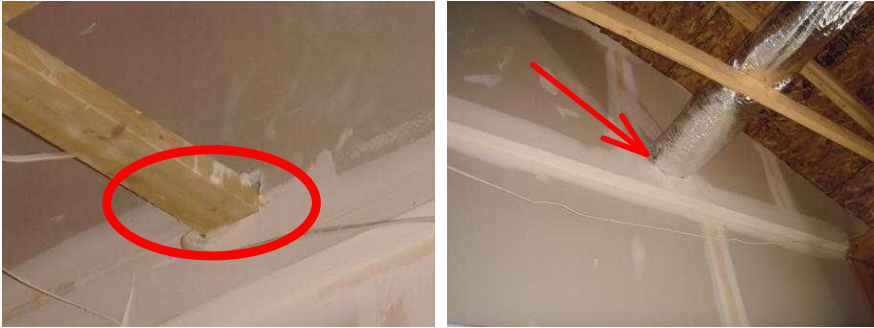
Garage Walls: Painted Drywall, Exposed framing- There are openings in the firewall that have not been sealed. IBC requires any penetrations in firewall (wall between home and garage) to be sealed to prevent free passage of fire. Recommend fire caulking be installed to seal any openings in wall.

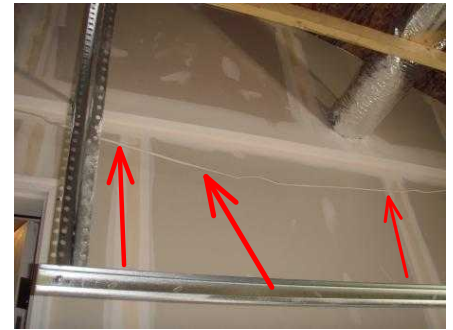
Garage Electrical: Lights/ GFCI outlet (s)- Electrical wire is hanging unsupported. Recommend supporting wire a minimum of every 4 1/2 feet (IBC) to avoid physical damage to wire.

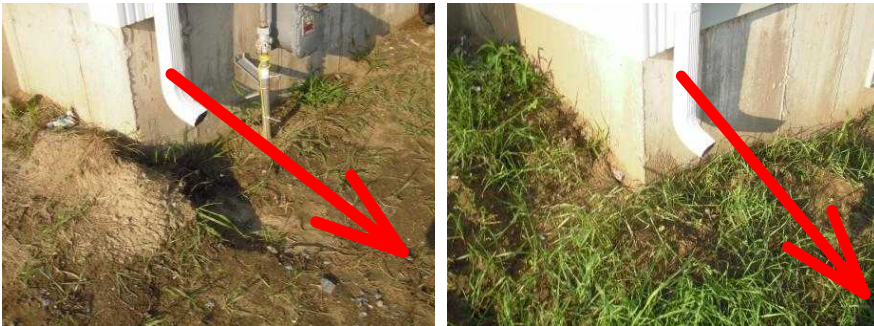
Leader/Extension: Missing- Recommend that leaders be installed as part of the gutter system and extend a minimum of 6' beyond foundation walls. This is an important measure in helping to maintain a dry basement. NOTE: Water that pools against foundation may eventually find its way in.

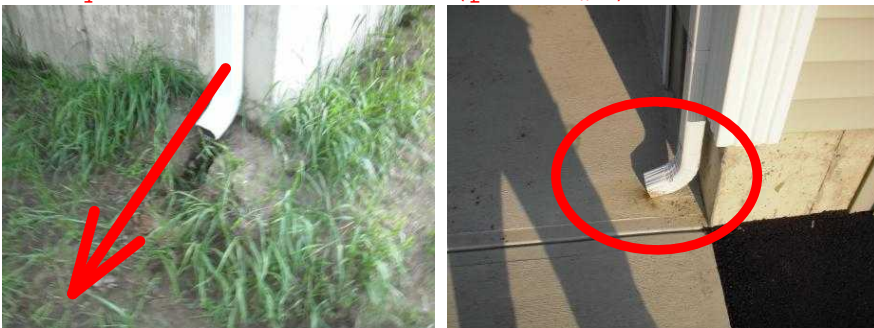
Garage Leader/Extensions: Missing- Leader missing at back of garage (photo #1). Recommend that leaders be installed as part of the gutter system and extend a minimum of 6' beyond foundation walls. This is an important measure to assure water does not get under concrete slab and compromise its integrity. Water that gets under slab may heave concrete and cause damage during the freeze and thaw cycles. Use extreme caution when using garage service door in the colder months as water may freeze at sidewalk (photo #2).
