Property Inspection Report

8 New Home Lane
All Towns, Vermont

Prepared for: Mr. and Mrs. Smart Buyer

Prepared by: Cramer Home Inspection Group, Inc.
7 Christmas Road
Montgomery Center, Vermont 05471

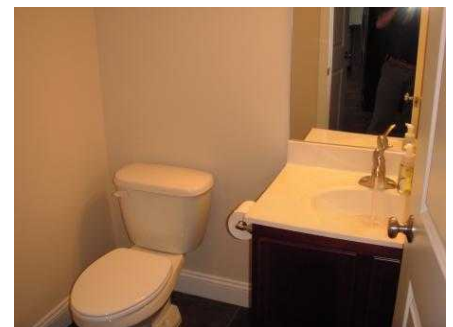
Picture:

Acceptable Walls: Painted Drywall
Acceptable Floor: Vinyl floor covering
Acceptable Doors: Wood
Acceptable Electrical: Vent fan/ light/GFCI outlet
Acceptable Counter/Cabinet: Wood cabinet
Marginal Sink/Basin: One piece sink/counter top- Although difficult to see, 1st photo shows crack in sink. Over time this crack will expand and may leak eventually. Recommend sink/counter top be replaced. 2nd photo shows missing caulk at counter top and wall intersection. Recommend caulking be installed to prevent water from getting between vanity and wall.

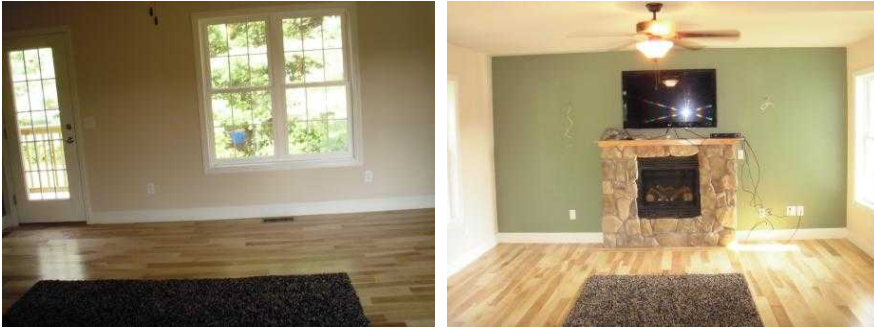
Living Room Living Space

Acceptable Ceiling: Painted Drywall
Acceptable Walls: Painted Drywall
Acceptable Floor: Hardwood
Marginal Doors: Metal Entry Door- Dead bolt lock/strike plate (circled)needs adjustment for ease of operation. Also handle side of door jam is bowed away from door slab. This may compromise the weather striping and let cold air enter. Recommend door be re-shimmed for an air tight fit.

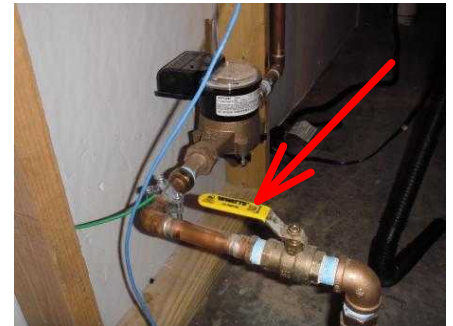
Acceptable Main Water Shutoff: -Located at water meter-
[Arrow points to main water shut off](#)

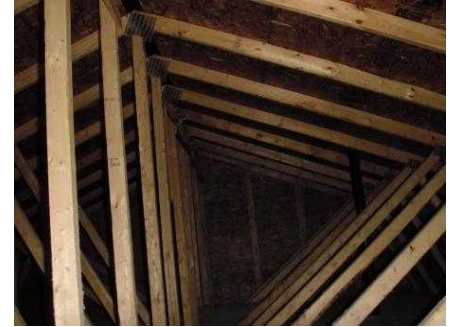
Acceptable	Roof Framing: 2x4 Truss
Acceptable	Sheathing: Particle board
Acceptable	Ventilation: Ridge/soffit vents
Acceptable	Insulation: Cellulose
Acceptable	Insulation Depth: 12-14 inches- The recommended R-Value for this climate is 39-49. At present time R-Value is approx. 45.5.
Not Present	Wiring/Lighting: No lights or outlets present in attic
Not Present	Moisture Penetration: None noted at time of inspection
